June 26, 2023  
Council Work Session Meeting

**CITY OF MOUNT HOLLY  
MOUNT HOLLY CITY COUNCIL WORK SESSION  
Location: Council Chambers**

FACILITY CONDITION  
ASSESSMENT

# FACILITY CONDITION ASSESSMENT

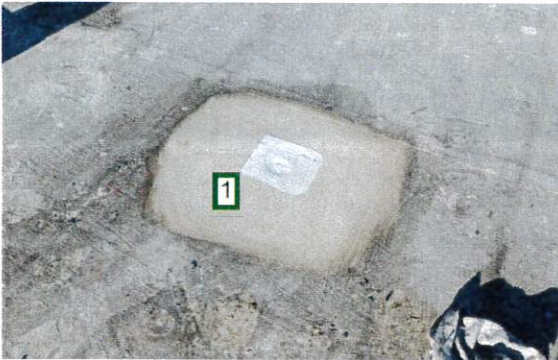
**Existing:** Upper Roof Existing Core (Location 1) with temporary patch.

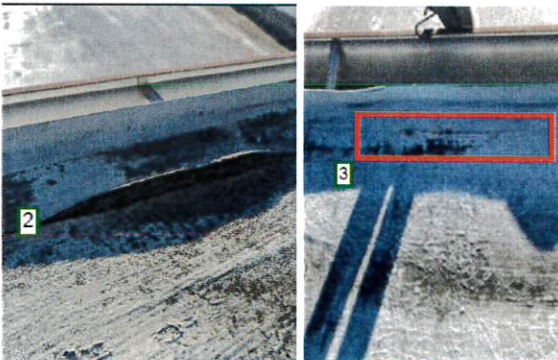
**Existing:** Upper Roof failed seam (Location 2) & additional roof tear (Location 3).

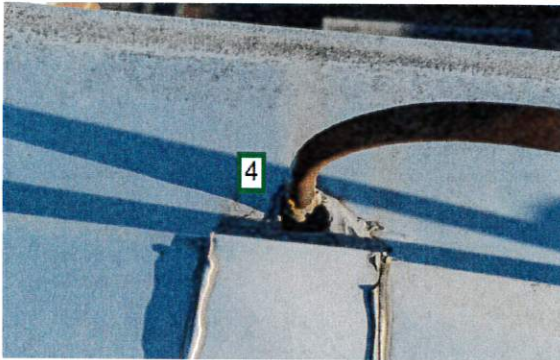
**Existing:** Upper Roof Conduit Penetration (Location 4).

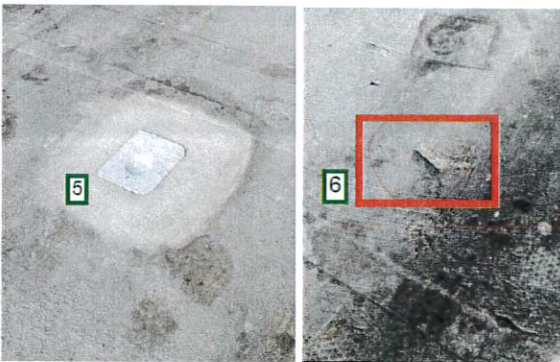
**Existing:** Lower Roof Existing Core (Location 5) with temporary patch and additional Roof Puncture (Location 6).

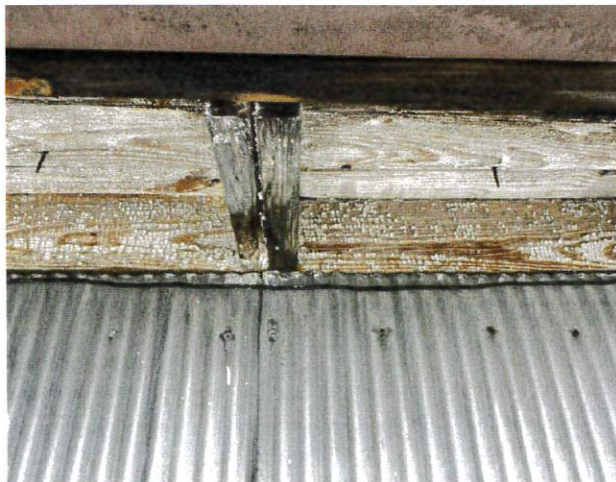
- Paint and surface coatings with contain detectable concentration of lead considered “lead-containing paints”. Since OSHA has no specific action level for lead in paint, all paint on the site found to have a measurable concentration of lead should be assumed to be lead-containing. Work performed which may disturb lead-containing paint is regulated under OSHA as referenced under 29 CFR 1926.62. **Nine Paint Chip samples were collected with six being classified as lead-based paint.** Paint and other surface coatings which are defined by applicable regulation as lead-based paints are summarized in the table below.

*View of White Lead Based Paint*

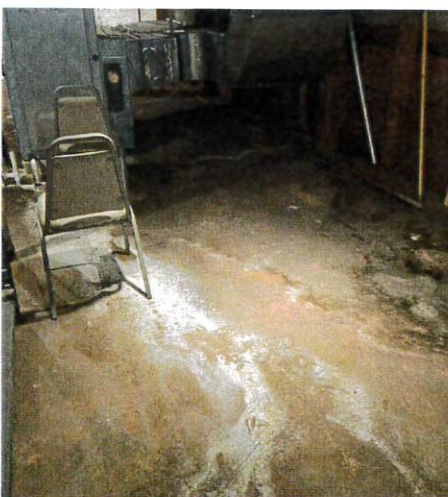
- The basement was observed to have significant delamination of plaster wall materials, at the front of the building this appears to be due to moisture intrusion through the brick. Water staining was observed on concrete floors in the basement. Moisture intrusion was apparent on carpeting and wall materials at the rear entrance of the building.

View of Water Staining on  
Concrete in the Basement

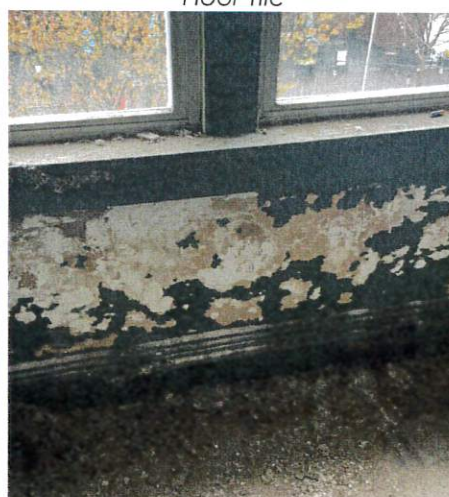
- Water damage was observed underneath front and side exterior windows and plaster is crumbling at these intrusion points.
- The first floor is conditioned and renovated space with drywall walls, drop ceilings and hardwood, carpeted and tiles floors. A small amount of water damage was observed on second floor decking above the drop ceiling.

View of Plaster Delamination  
below Windows

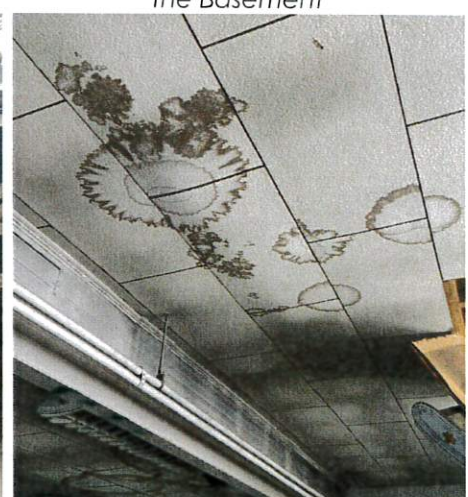
- The second floor is vacant and did not appear to be a conditioned space at the time for our assessment. This floor has not been renovated, and appears to have been left vacant for a considerable period of time. Roof likely not active and from previous water intrusion events are evident on ceiling tiles, roof decking, and tile flooring.

View of Old Roof Leak

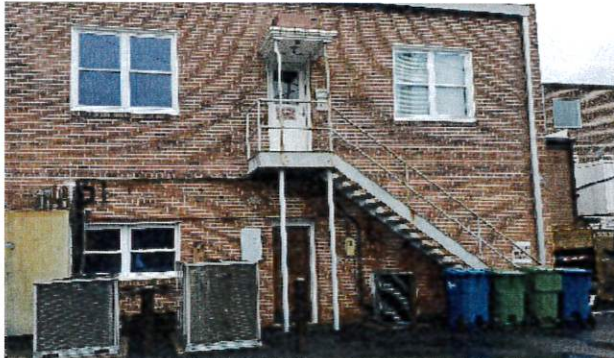
*Exterior Stairs that need repair/replace*

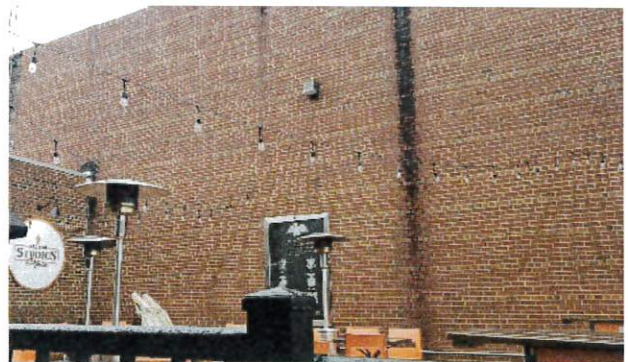
*Roof drain from roof in need of repair*

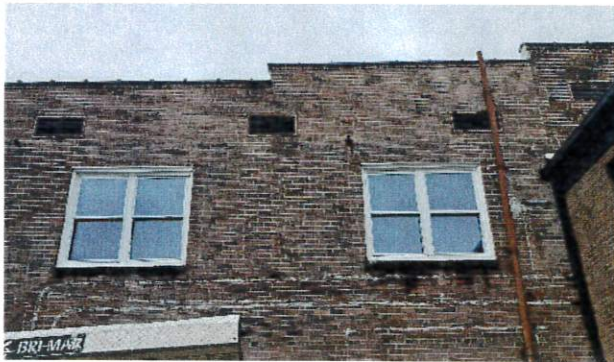
*Flashing under windows need addressing*

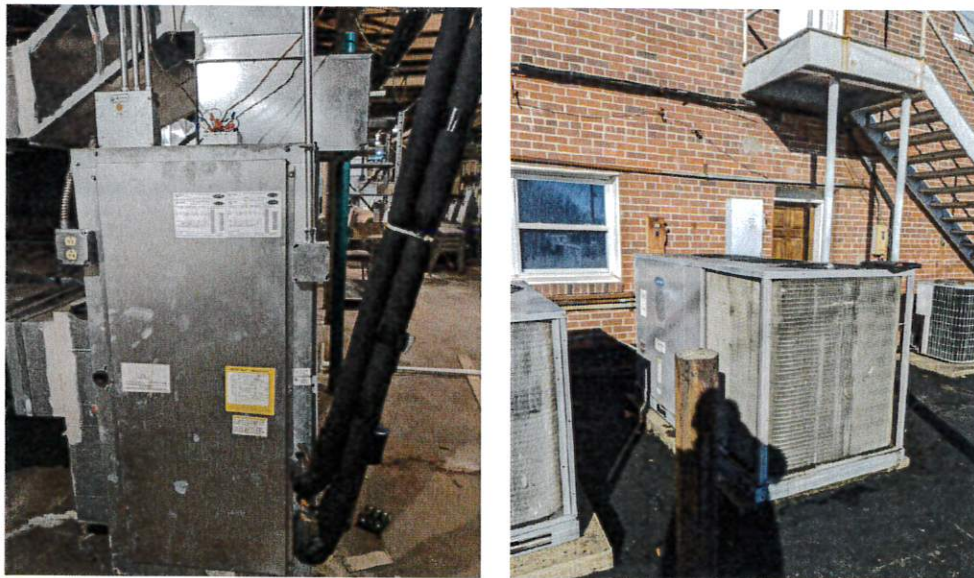
- Air Handler #1 is located in the basement and serves a portion of the main level of the building and part of the basement. It is manufactured by Carrier, provides 6,000 CFM of conditioned air, and was built in 2011. The unit is controlled by a wall mounted 7-day programmable thermostat. Associated condensing unit is manufactured by Carrier and was built in 2011 and is located on grade at the rear of the building. There are no known issues with this unit, and it has approximately 3 years of useful life remaining.

*Air Handler #1 / Condensing Unit #1*

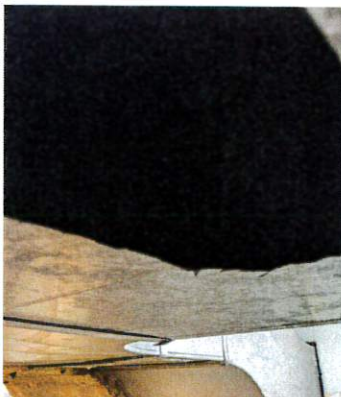
- A portion of the ductwork serving Air Handler #1 is routed exposed in the basement and is not insulated. There are holes in the ductwork. The duct will have to be patched or replaced.

*Exposed ductwork in basement with hole and no insulation*

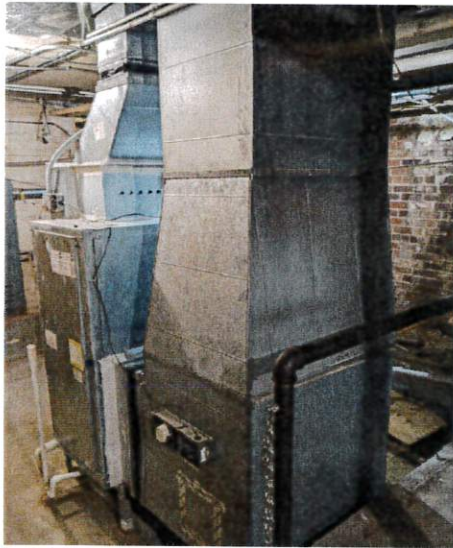
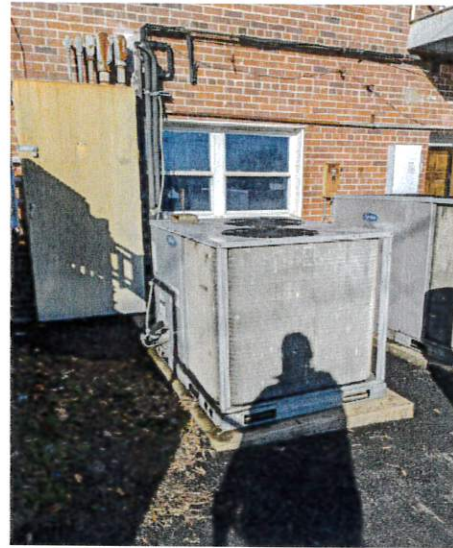
- Air Handler #2 is located in the basement and serves a portion of the main level of the building. It is manufactured by Carrier, provides 3,000 CFM of conditioned air, and was built in 2011. The unit is controlled by a wall mounted 7-day programmable thermostat. Associated condensing unit is manufactured by Carrier and was built in 2011 and is located on grade at the rear of the building. There are no known issues with this unit, and it has approximately 3 years of useful life remaining.

*Air Handler #2/ Condensing Unit #2*

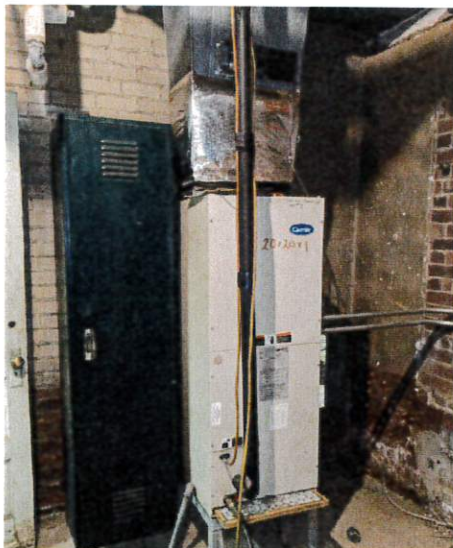
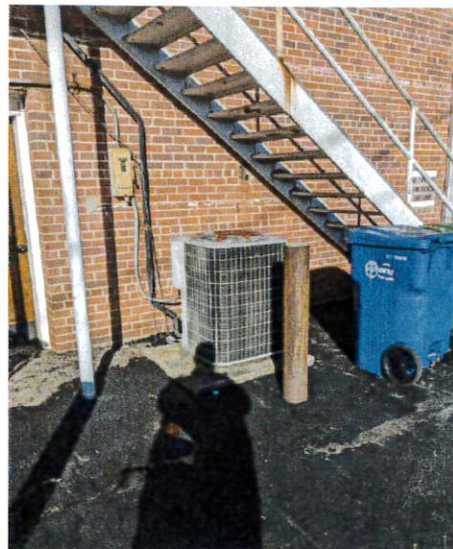
- Air Handler #3 is located in the basement and serves a portion of the basement. It is manufactured by Carrier, provides 2,000 CFM of conditioned air, and was built in 2000. The unit was controlled by a wall mounted thermostat. Associated condensing unit is manufactured by Carrier and was built in 2000 and is located on grade at the rear of the building. The split system is not operable and is past its useful life.

*Air Handler #3/ Condensing Unit #3*

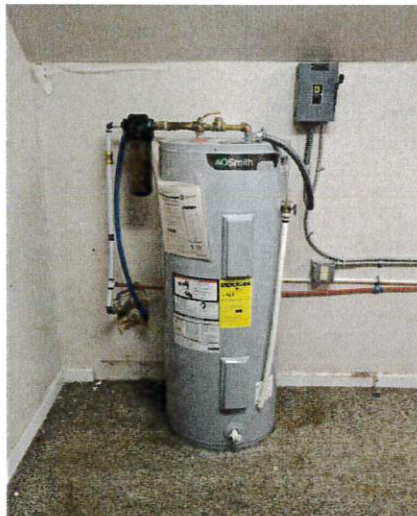
- The Hot Water for the building is provided by one (1) electric water heater located in the basement. The water heater is manufactured by A.O. Smith in 2021 and has a capacity of 40 gallons, with two non-simultaneous 4.5 Kw heating elements. It is equipped with a water filter. At the time of the visit the water heater had a small leak. The owner was made aware and had advised AME that a repair was already requested.

*Water Heater*

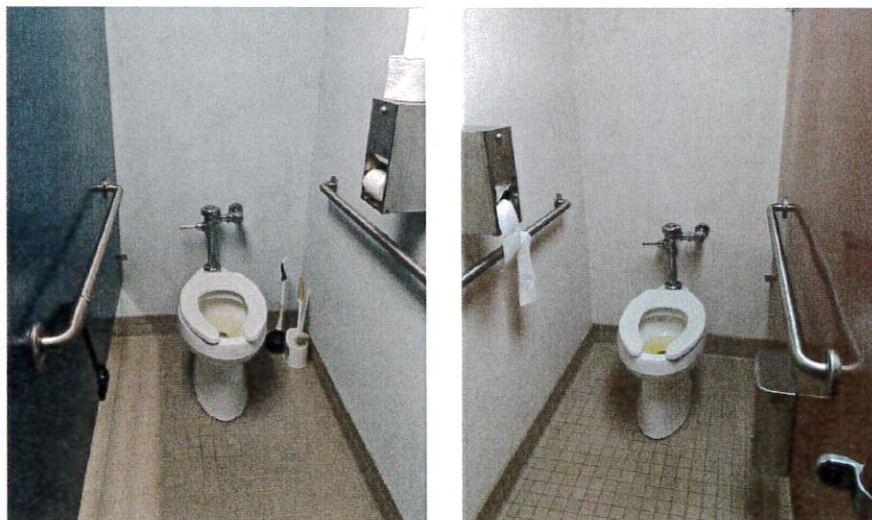
- The plumbing fixtures for the main level of the building are in working order, some of the toilets have yellow staining. The men's and women's restrooms do not meet current ADA requirements.

*Main Level Men's and Women's Toilet*

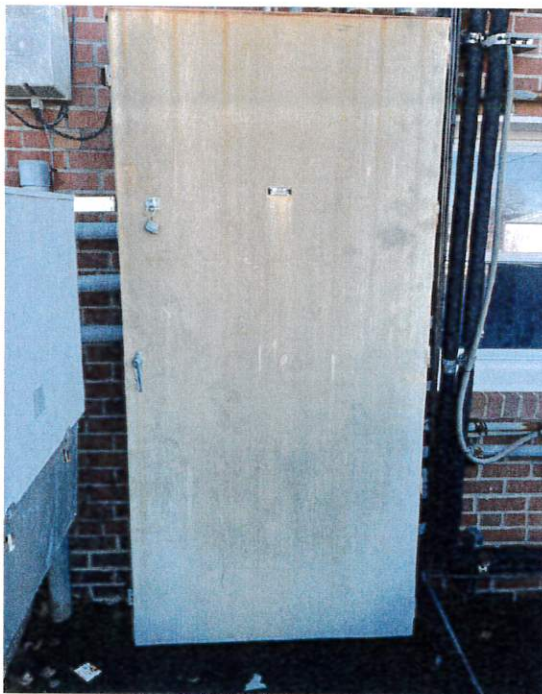
- Power is distributed from the main distribution panel to panelboards on each floor. The power distribution equipment and wiring on the first floor and in the basement appear to have been upgraded to meet current codes. There is still some old power wiring installed on these floors but has been abandoned and is no longer active. The power distribution equipment and wiring on the 2nd floor is very old and does not meet current codes. All of this should be removed and replaced if this space will be utilized.

*Main Distribution Panel*

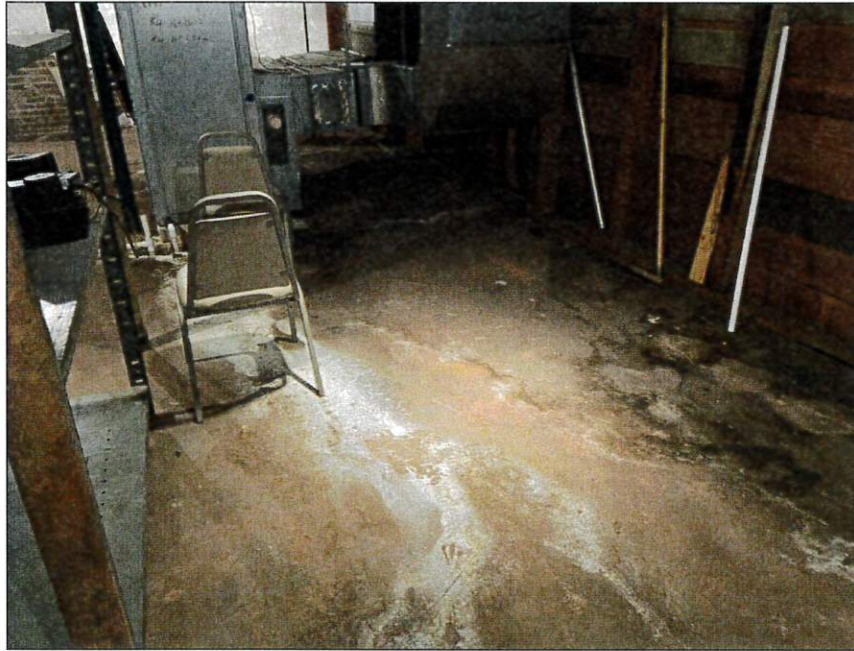
13 - View of water staining on concrete in the basement.

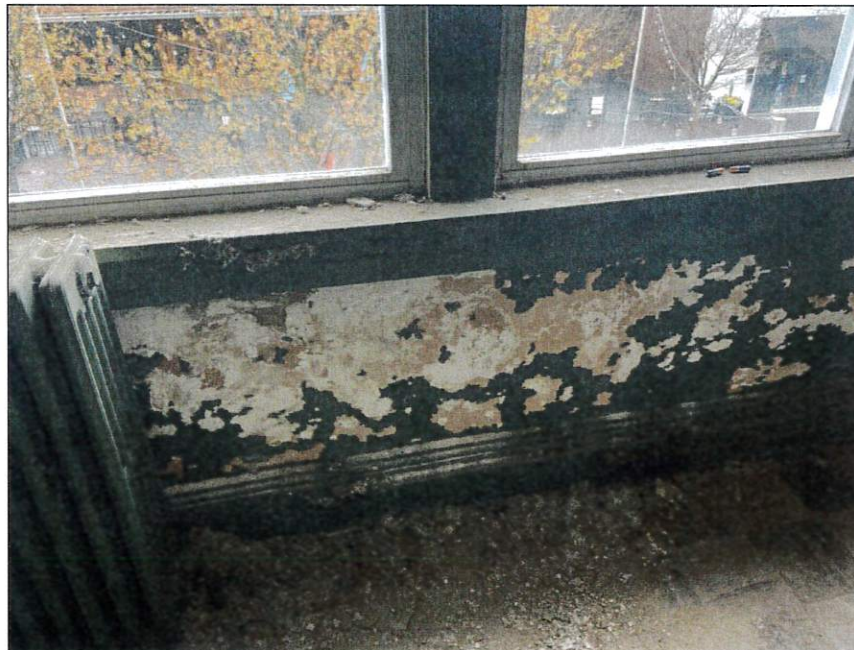
14 - View of plaster delamination below windows

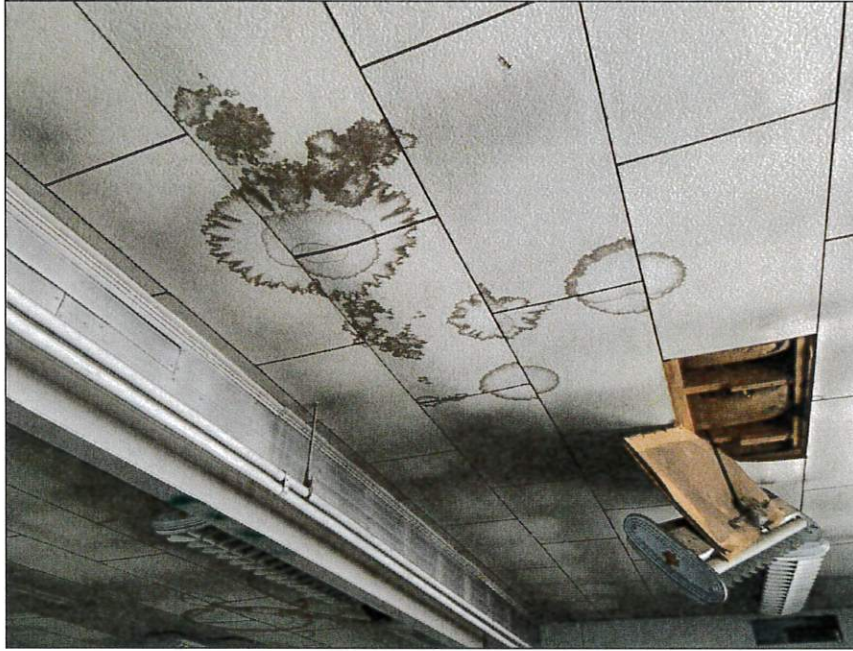
15 - View of old roof leak.
