June 26, 2023  
Council Work Session Meeting

**CITY OF MOUNT HOLLY  
MOUNT HOLLY CITY COUNCIL WORK SESSION  
Location: Council Chambers**

FACILITY CONDITION  
ASSESSMENT

# FACILITY CONDITION ASSESSMENT

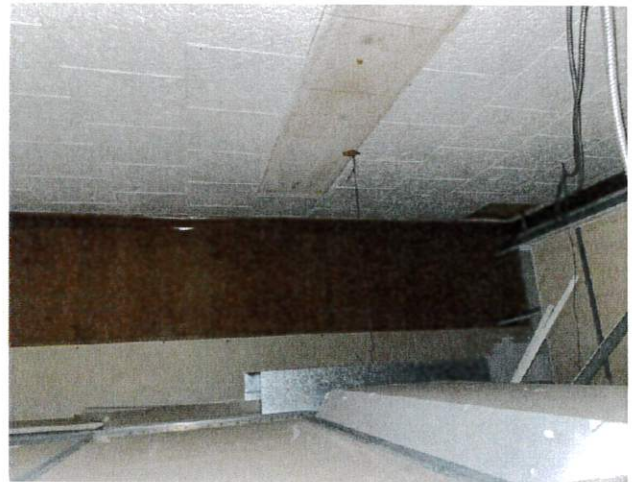
*Sampled splined ceiling tiles*

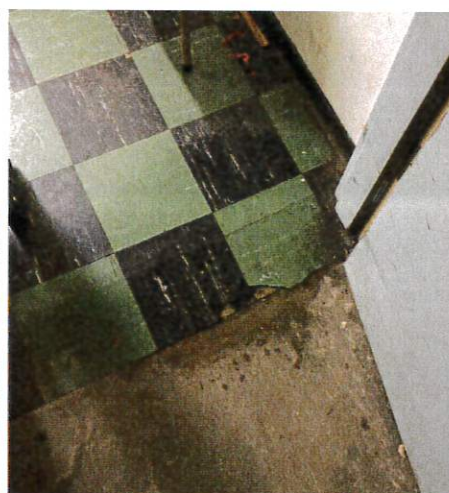
View of Asbestos-Containing  
Floor Tile

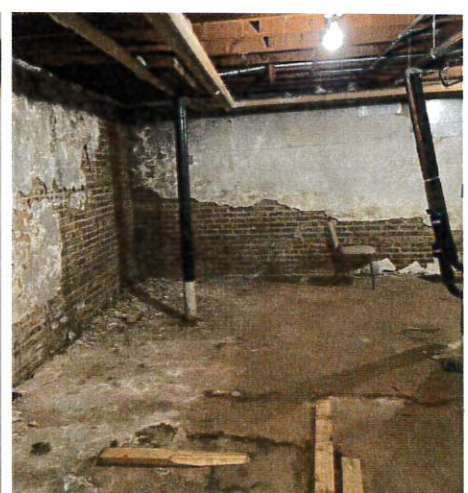
- The basement was observed to have significant delamination of plaster wall materials, at the front of the building this appears to be due to moisture intrusion through the brick. Water staining was observed on concrete floors in the basement. Moisture intrusion was apparent on carpeting and wall materials at the rear entrance of the building.

View of Plaster Delamination in  
the Basement

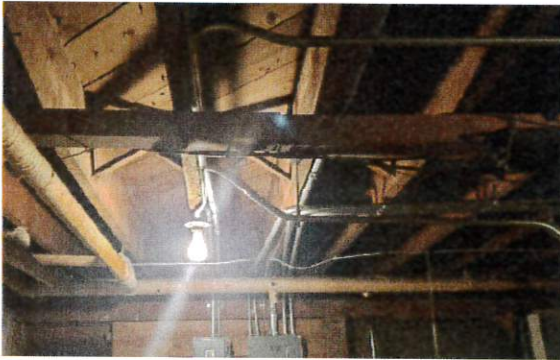
*Basement girder that needs a column*

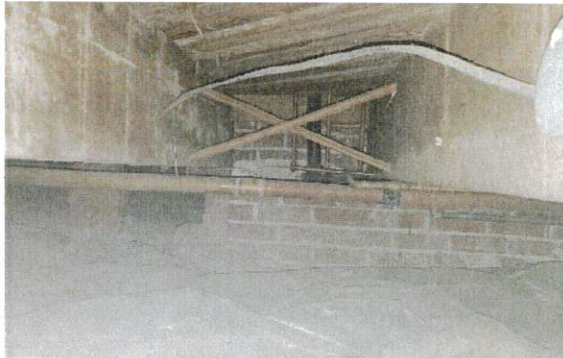
- Currently the front portion of the basement towards Main Street is primary mechanical systems in the unfinished space. The addition portion of the space is currently being used for town storage. There are finished bathrooms located at the base of the stairs. The bathrooms are on a framed joist floor with very low crawl space.

*Floor Framing in basement bathroom*

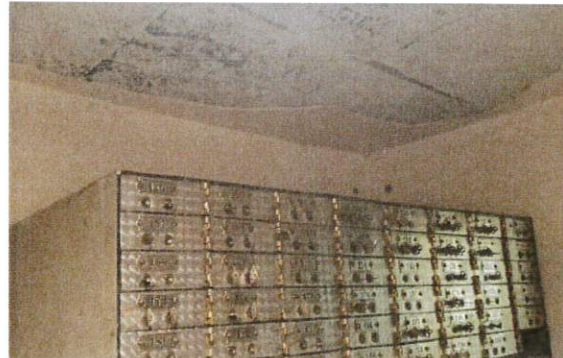
*Concrete wall at the vault*

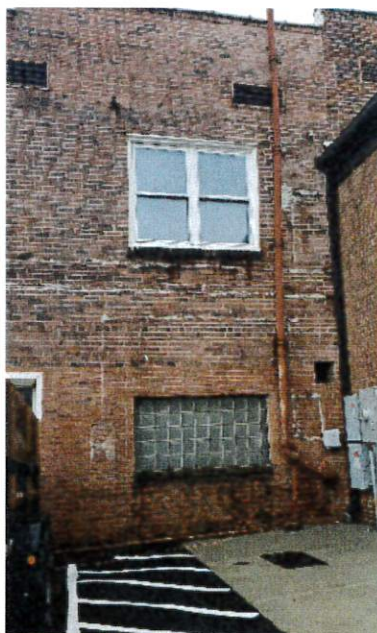
*Flashing under windows need addressing*

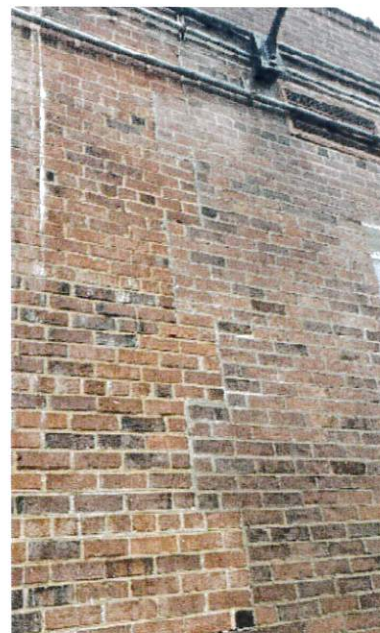
*Joint at addition*

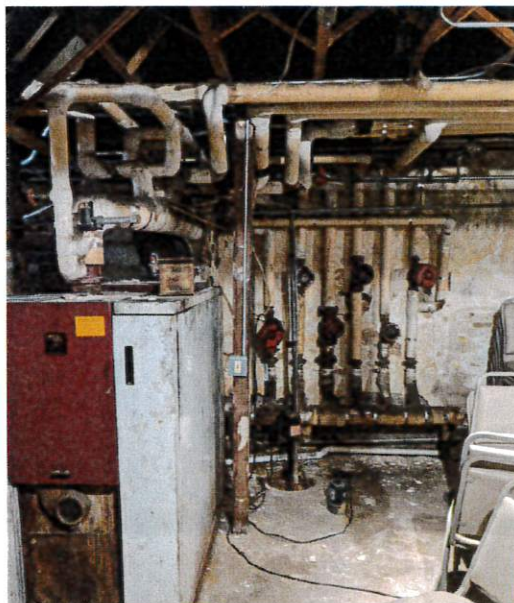
- There is an abandoned boiler and associated piping in the basement. The boiler was used to provide heating to the building.

*Basement Level Abandoned  
Boiler and Associated Piping*

- It is recommended the abandoned boiler and associated piping be removed in their entirety.
- It is recommended the abandoned pumps and associated piping be removed in their entirety.

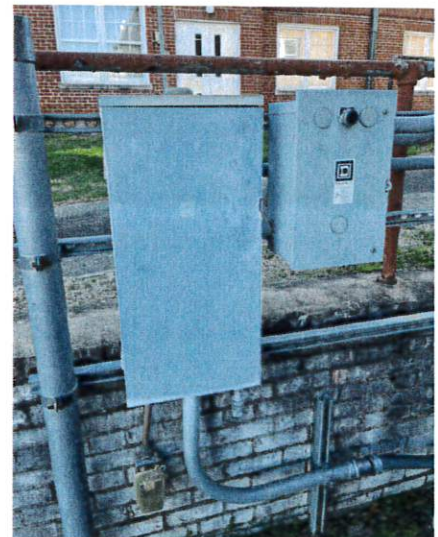
*Street Lighting Panel at  
Rear of Building*

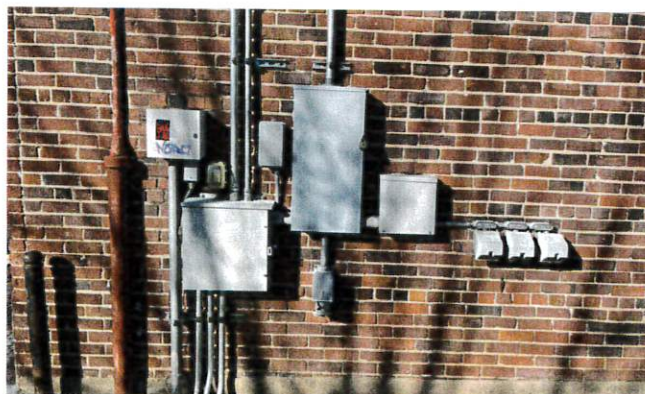
*Street Lighting/Shore Panel  
at Front of Building*

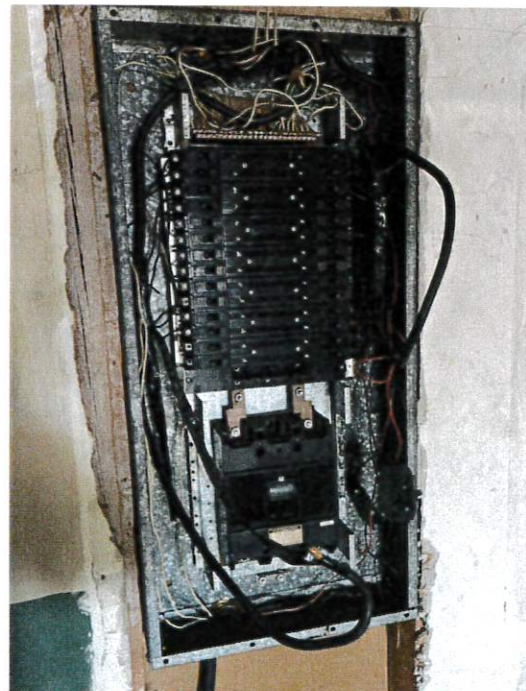
- Power is distributed from the main distribution panel to panelboards on each floor. The power distribution equipment and wiring on the first floor and in the basement appear to have been upgraded to meet current codes. There is still some old power wiring installed on these floors but has been abandoned and is no longer active. The power distribution equipment and wiring on the 2nd floor is very old and does not meet current codes. All of this should be removed and replaced if this space will be utilized.

*2nd Floor Panel*

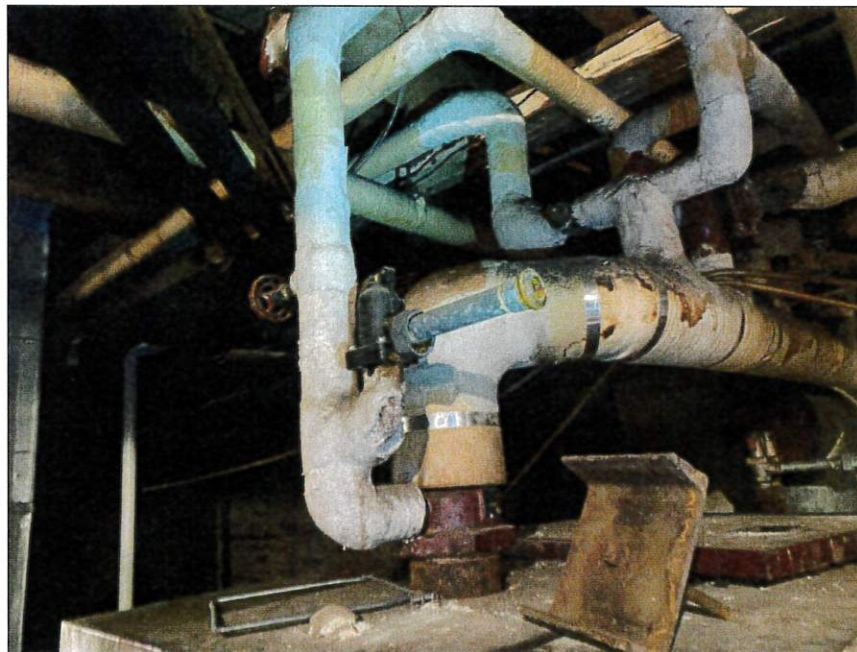
2 - View of asbestos-containing pipe elbows

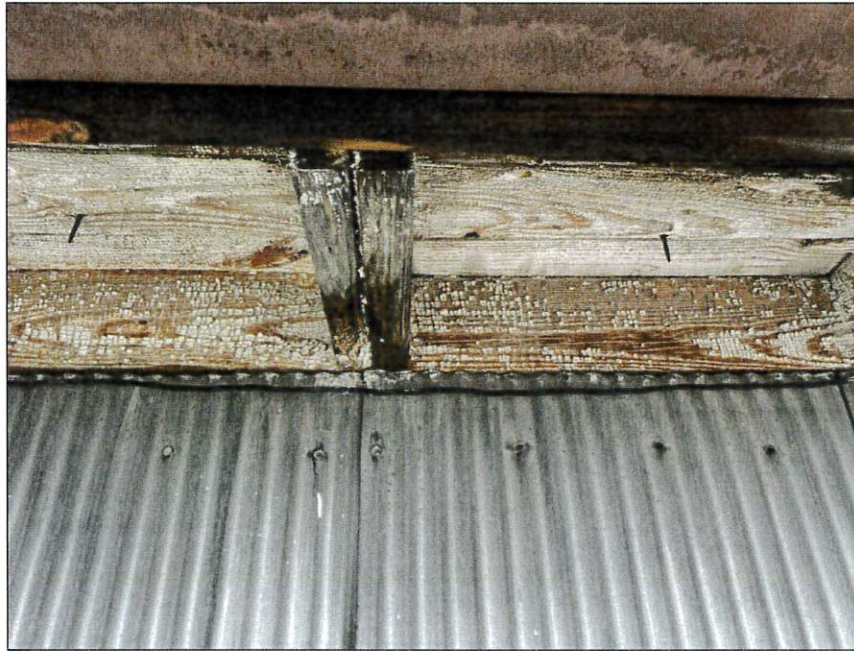
5 - View of white lead based paint

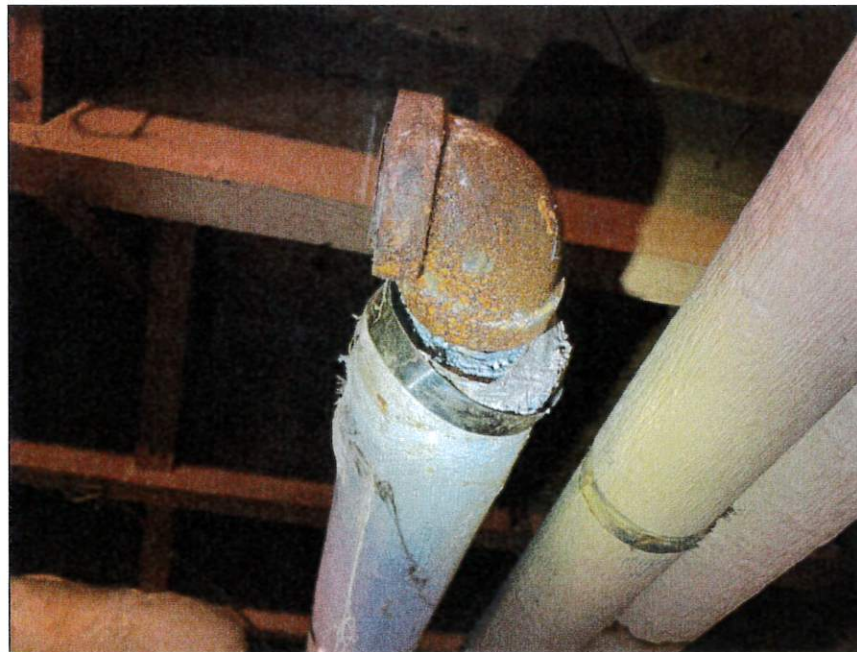
6 - View of air-o-cell pipe insulation

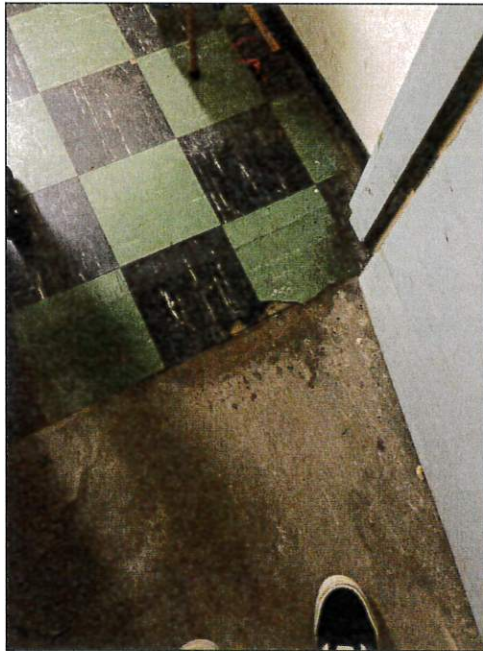
11 - View of asbestos-containing black and green floor tile

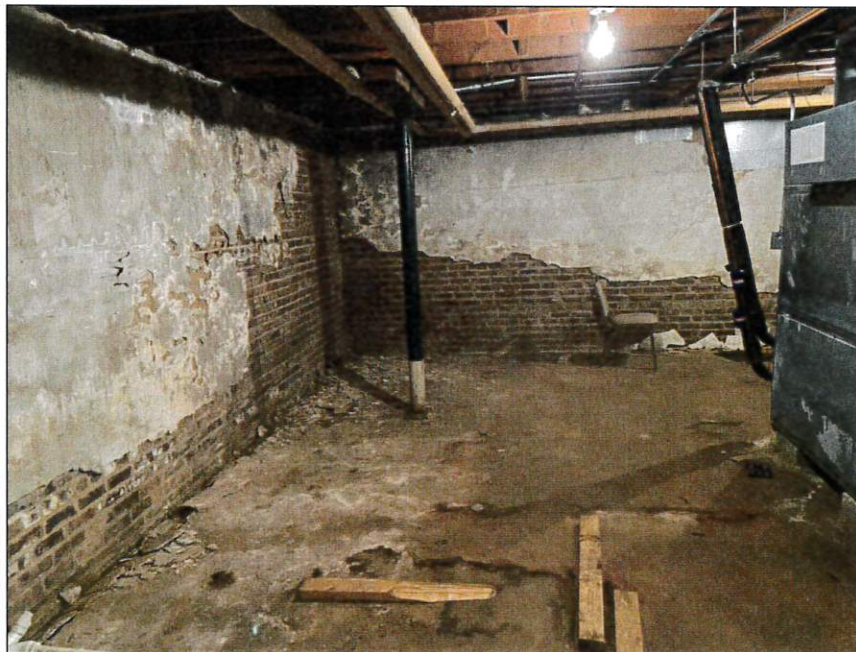
12 - View of plaster delamination in the basement.
