June 26, 2023  
Council Work Session Meeting

**CITY OF MOUNT HOLLY  
MOUNT HOLLY CITY COUNCIL WORK SESSION  
Location: Council Chambers**

FACILITY CONDITION  
ASSESSMENT

# FACILITY CONDITION ASSESSMENT

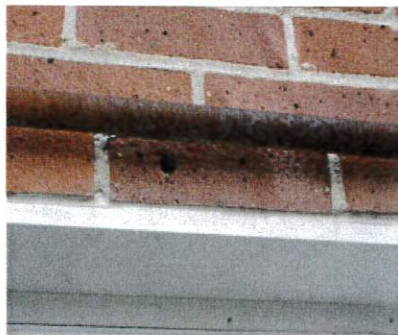
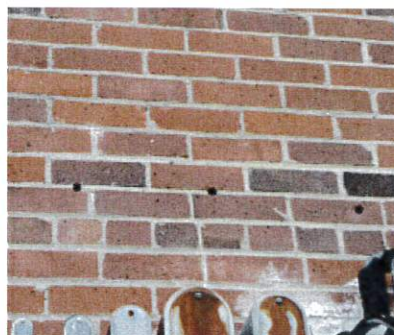
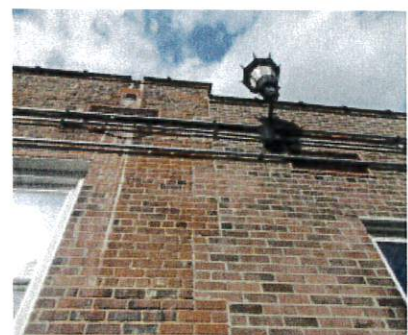
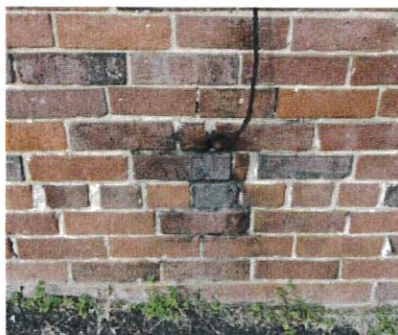
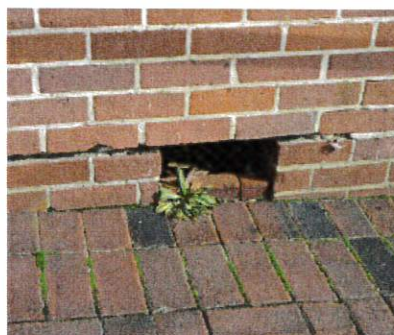
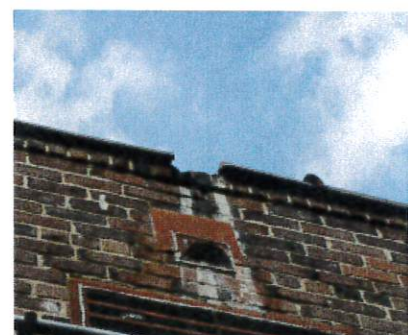
### 1. EXTERIOR FACADE

- The building façade consists of two generations of brick masonry, one for the original portion of the building (eastern two-thirds) and one for the addition (western third). In addition, the brick on the western portion of the northern elevation appears to be newer and similar to that of the addition. The brick is presumed to be original to the respective construction dates; approximately 1920 for the original portion of the building and unknown for the addition/north elevation.

- The original brick is generally in good condition with some isolated damage, including cracks and spalls. Replacing the damaged bricks is recommended. It's unclear if the mortar is original or if repointing has occurred at some time. The mortar is generally in fair condition and age-related deterioration/weather was observed, with some isolated areas being worse than others. In general, the mortar appears to have lost 1/8-1/4 inch from the surface. Repointing of the brick is recommended.
- The newer brick and mortar is generally in very good condition.

- Holes and unsealed penetrations were observed, primarily on the rear and south elevations, although some isolated ones were observed throughout. The building does not appear to have any waterproofing and relies on the brick itself to keep water out. Sealing any holes/penetrations is critical to the brick's waterproofing role.
- Staining was observed in various areas of the brick. In some areas, the staining is general in nature, such as dark microbial growth in areas with limited sun exposure such as the north elevation. In other areas, the staining is the result of water from the parapet walls. We recommend cleaning the brick to remove the staining. Issues with the parapet walls can be remediated during roof work to prevent further staining.

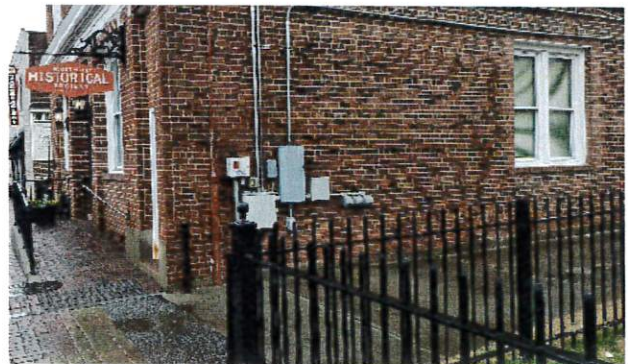
*Exterior and entry ramp corner*

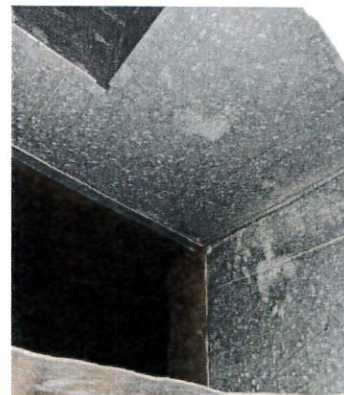
*Exposed ductwork in basement with hole and no insulation*

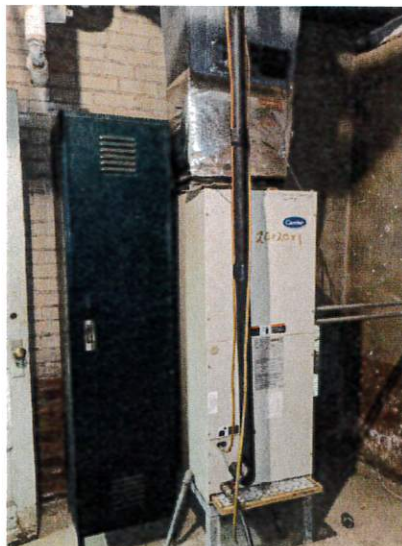
*Second Level Exposed  
Abandoned Ductwork*

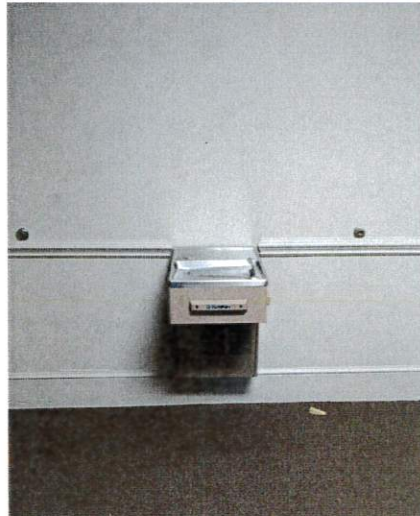
- The main level has one drinking fountain.

*Drinking Fountain*

- The main level restrooms and drinking fountain need to be brought up to current ADA standards.
- The basement level restrooms need to be repaired and brought up to current ADA standards.

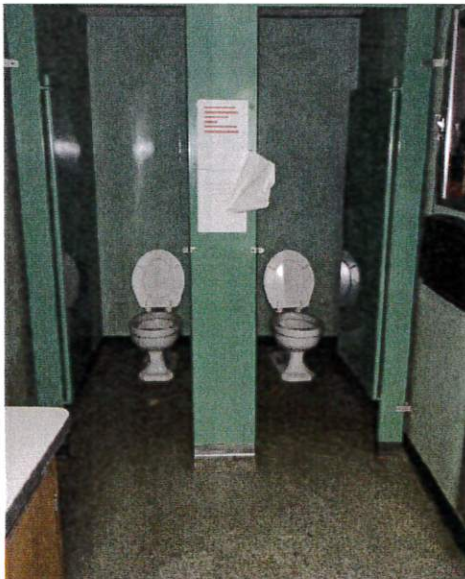
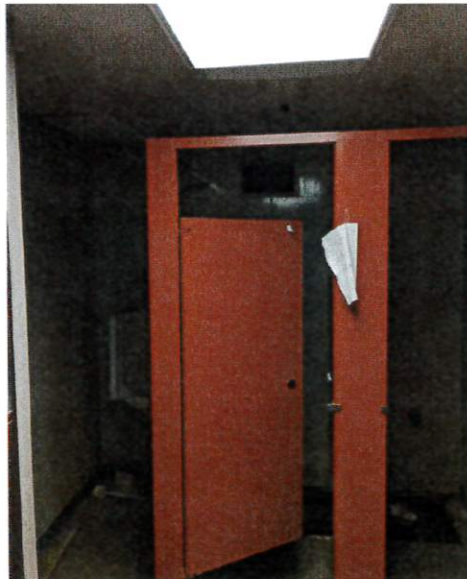
- The plumbing fixtures in the basement level of the building are not operational. The men's and women's restrooms do not meet current ADA requirements.

*Basement Level Men's and Women's Toilet*

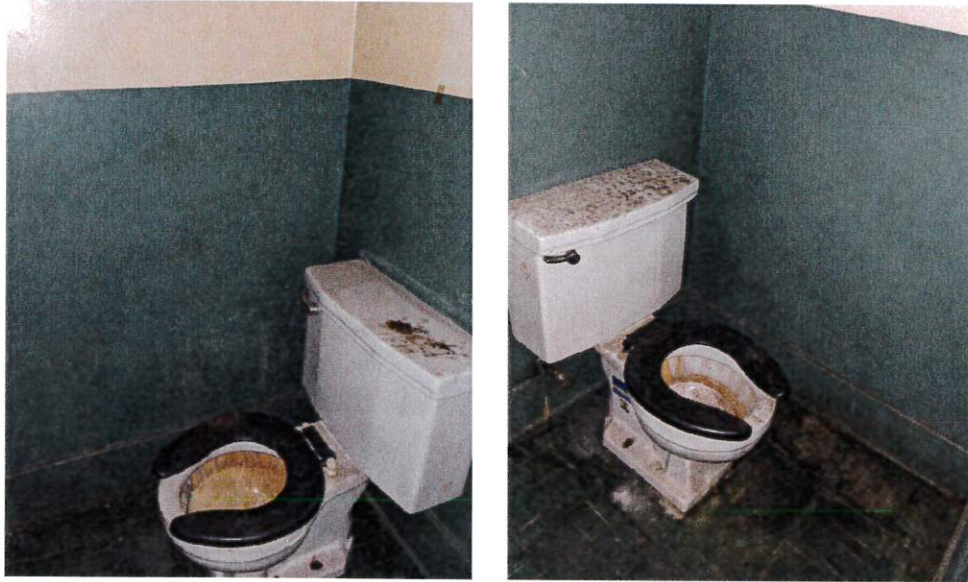
- The plumbing fixtures on the second level of the building are not operational. The men's and women's restrooms do not meet current ADA requirements.

*Second Level Men's and Women's Toilet*

- The second level restrooms need to be repaired and brought up to current ADA standards.
- The water heater needs to be brought up to code. A drain pan, Thermostatic mixing valve, and an expansion tank are required.

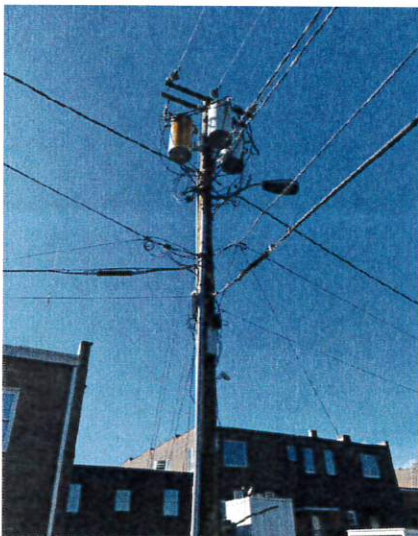
*Service Transformer*

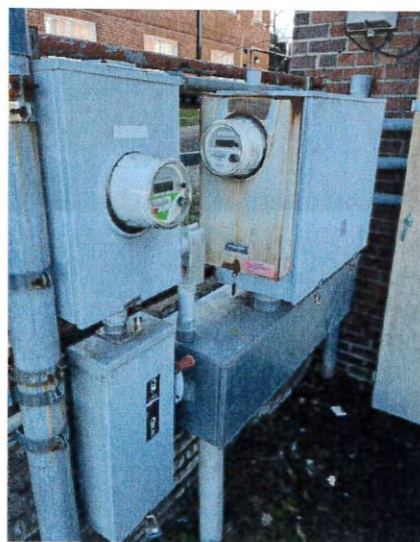
*Wireway and Meters*

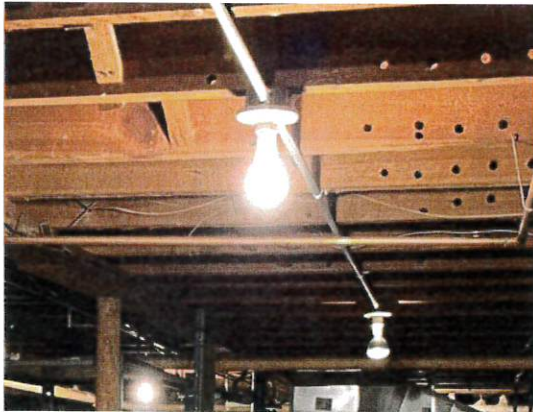
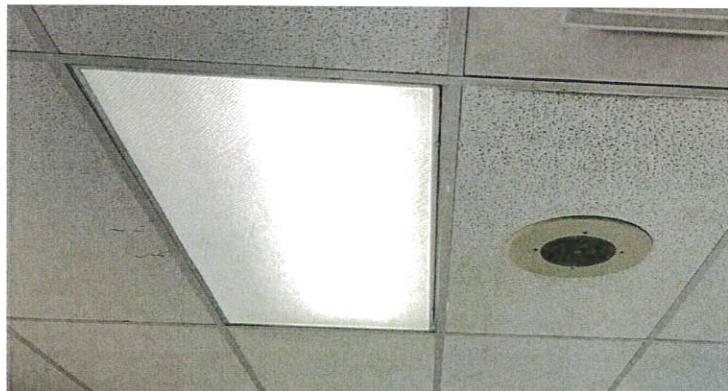
- The lighting in the building is a mixture of incandescent A bulbs, fluorescent downlights, fluorescent troffers and fluorescent industrial fixtures. All of the fluorescent fixtures in the building are either T8 or T12 lamps. None of these fixtures meet today’s energy standards. There are currently no plans to upgrade to LED. There is not a lighting control system. Typical controls are manual, with occupancy sensors as required and some manual dimmers.
- The building has standardized LED exit signs and “bug-eyed” emergency egress fixtures.
- The exterior building lighting are well mounted lights. The wall mounted lights are utilizing LED screw in bulbs. The site lighting is controlled through photocells. There does not appear to be any emergency egress lighting outside at the exterior exits as required by code.

*Typical Lighting*

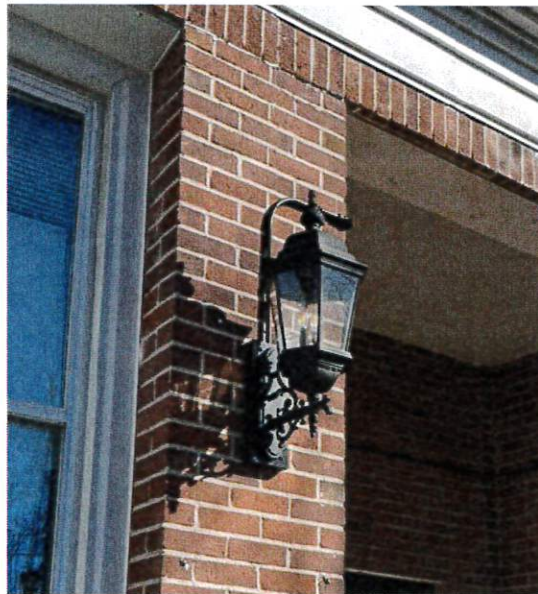
- Summary of lighting per floor:
  - Basement - Mixture of Incandescent Fixtures and older T12 Fluorescent Fixtures. The lighting levels are not adequate. Exit Signs and emergency egress lighting spacing and locations do not meet current code.
  - 1st Floor - Mixture of Fluorescent Down lights and T8 Fluorescent Fixtures. The lighting levels appear to be adequate. Exit Signs and emergency egress lighting spacing and locations appear to meet current code. A few locations may need to be added.
  - 2nd Floor - Mixture of Incandescent Fixtures and older T12 Fluorescent Fixtures. The lighting levels are not adequate. No exit signs or emergency egress lighting is installed.

*Exterior Lighting*
